TTI ENVIRONMENTAL, INC.

TTI Project No. 20-763

SITE INVESTIGATION / REMEDIAL INVESTIGATION REPORT

Reliable Tire Co
1115 Chestnut Street
Block 1302, Lot 1
Camden, Camden County, New Jersey 08103

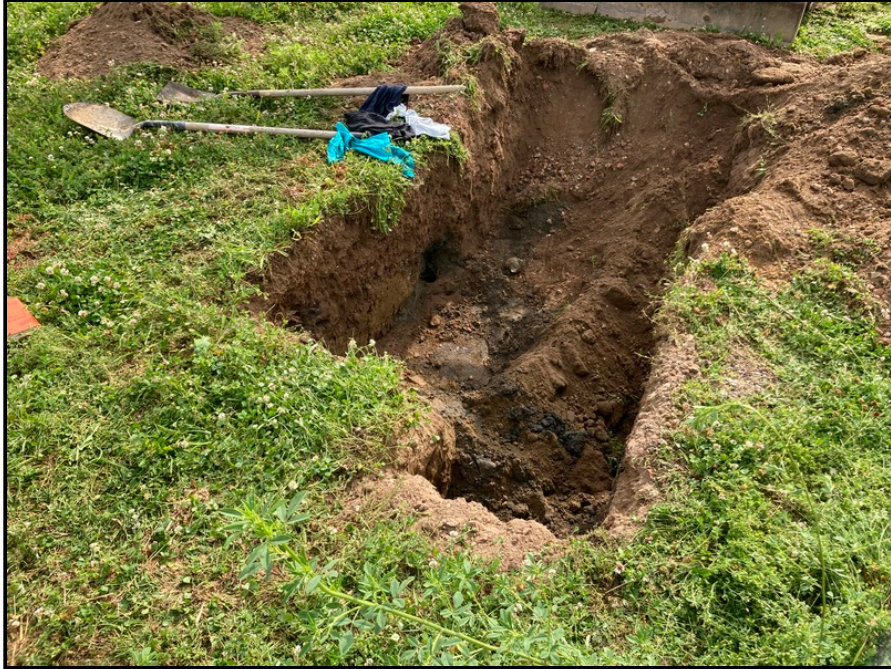
The tops of the USTs were daylighted using an excavator. Excavated soils were staged on soils adjacent to AOCs 1D and 1E. No evidence of obvious contamination was identified during soil excavation, except for the presence of approximately two square feet of stained soils located above the eastern unknown UST (AOC D). The stained soils smelled moderately of petroleum.

The tops of the two USTs were located approximately 3 feet bgs and the USTs were approximately five feet in diameter each. TTI opened the fill ports of the two USTs and observed mixtures of rain water and petroleum product within each UST. Approximately one inch of sludge was observed in the bottom of AOC 1D.

Excavation exposing the tops of AOCs 1D and 1E

TTI recommended the removal of the two USTs per NJDEP UST removal guidance and the registration of the two USTs with the NJDEP.

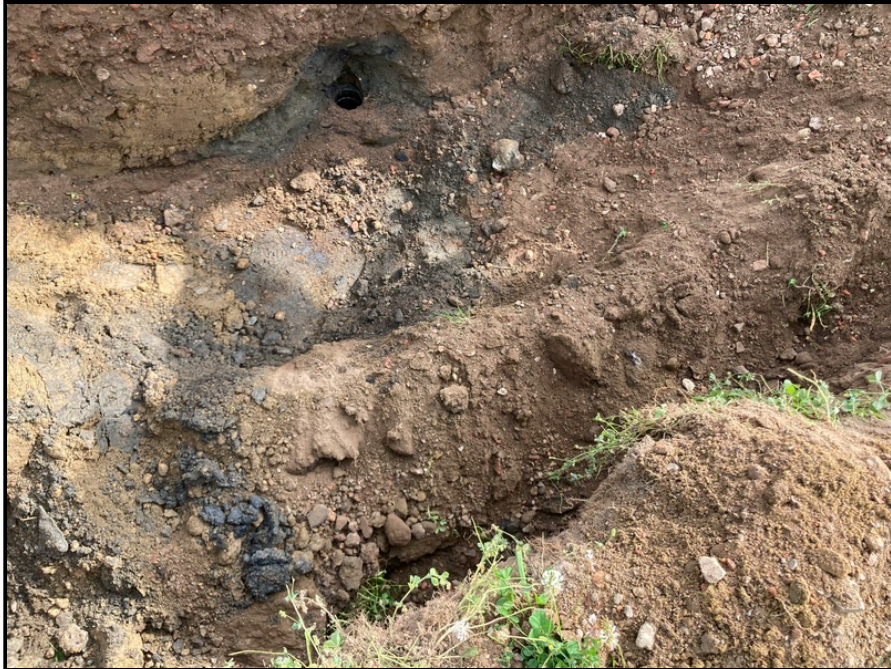
Stained soils in the vicinity of the fill port of AOC D

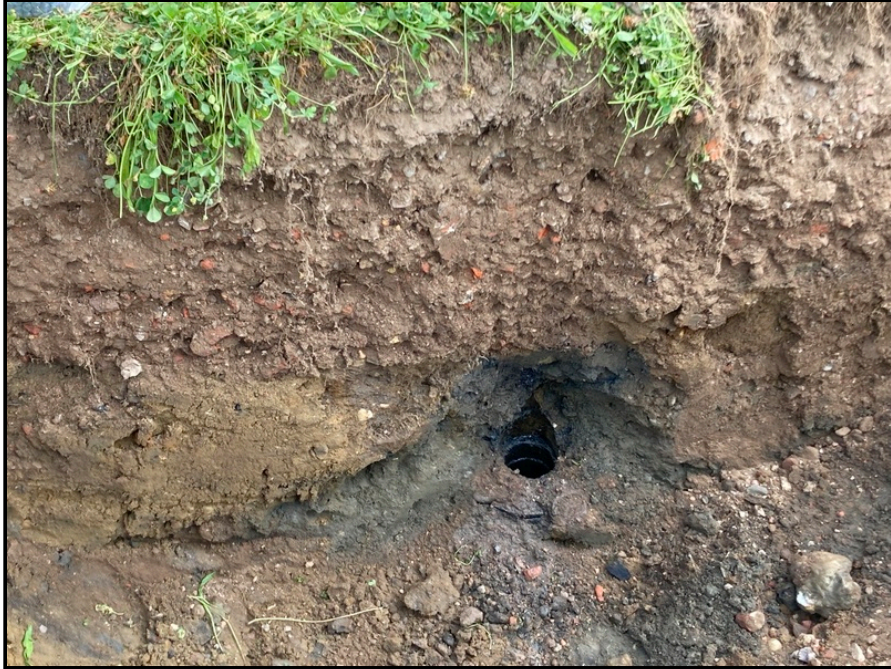
Fill port of AOC D

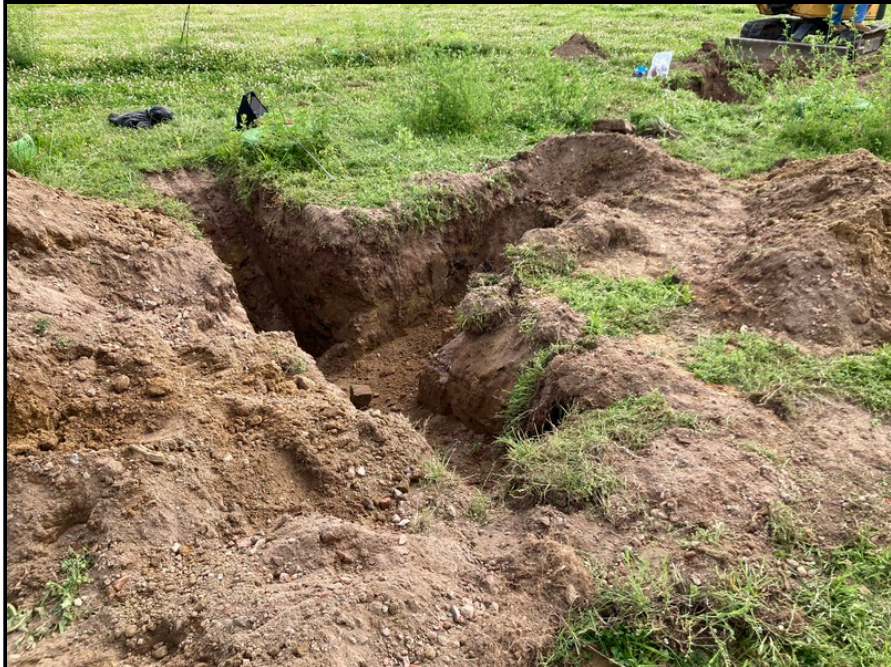
Excavation daylighting AOC E

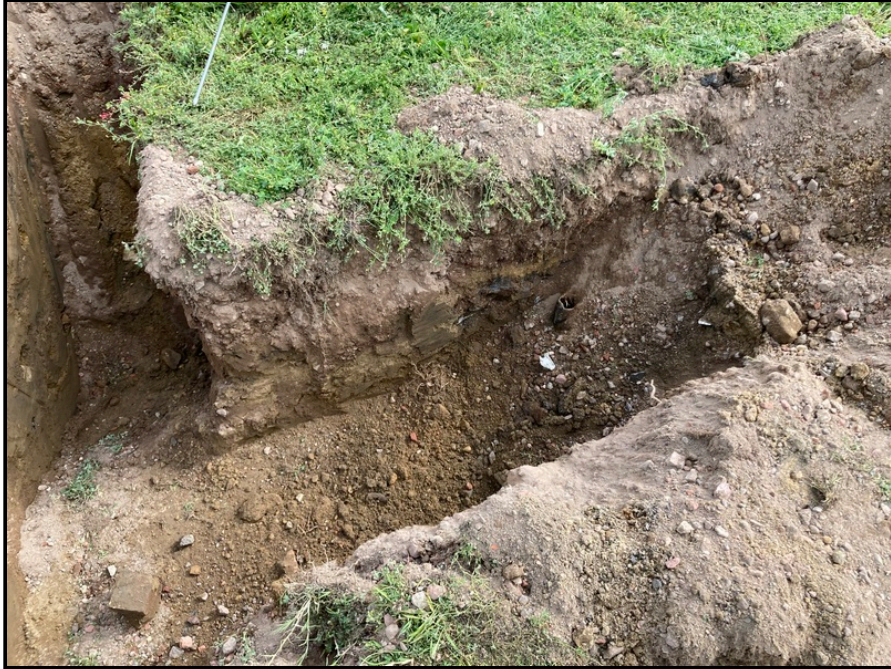
Excavation daylighting AOC E; fill port is visible

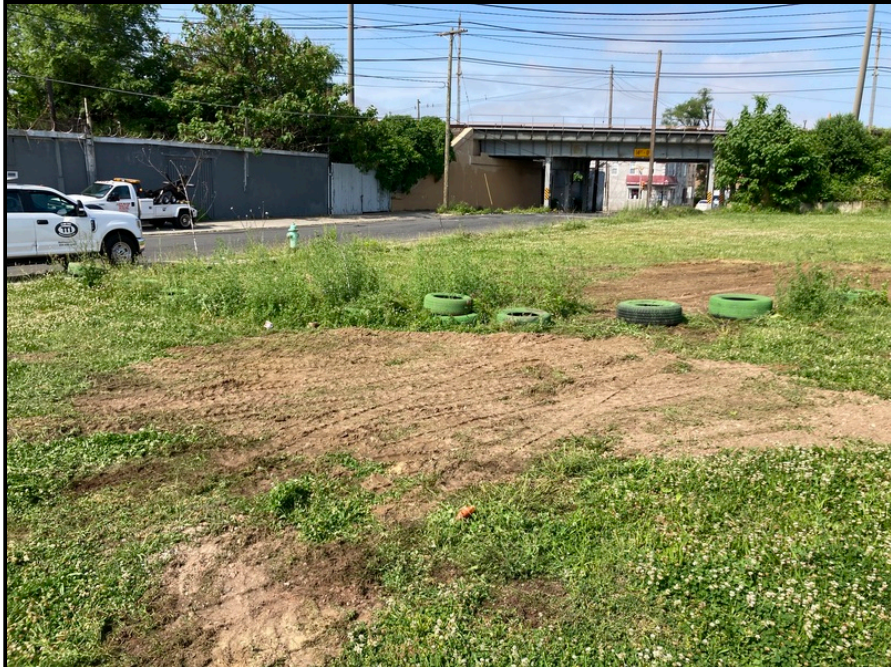
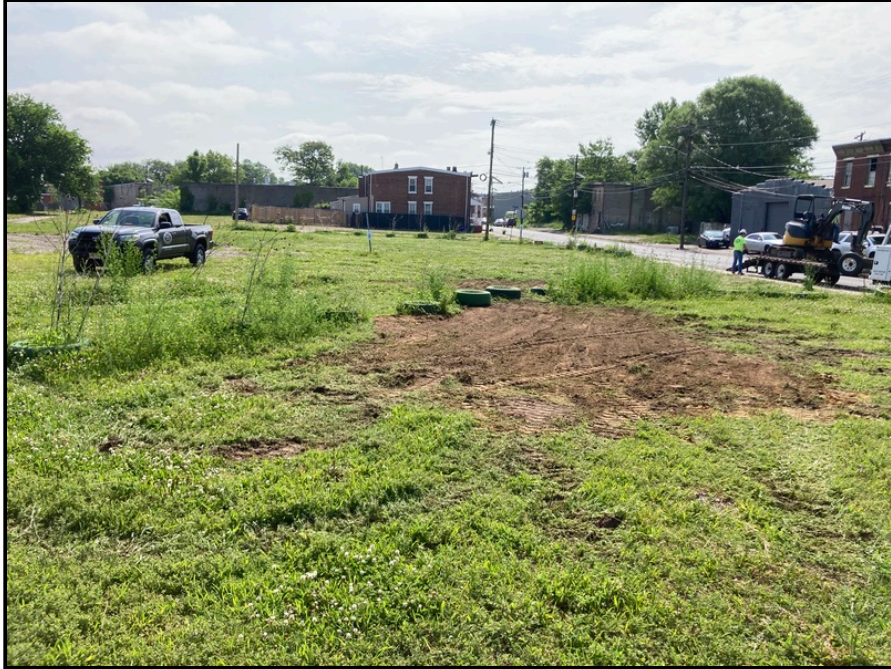
Backfilled excavations of AOCs D and E

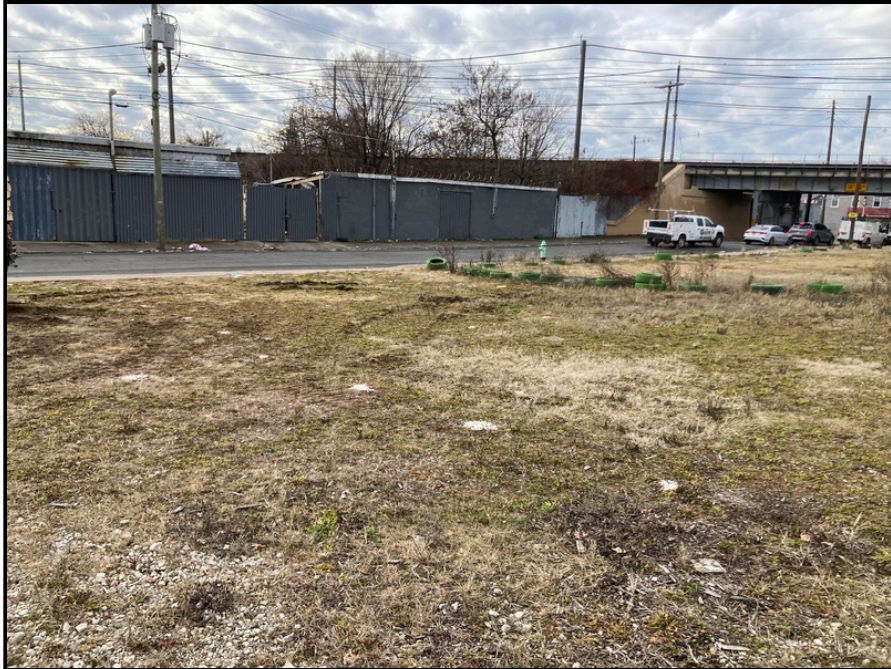
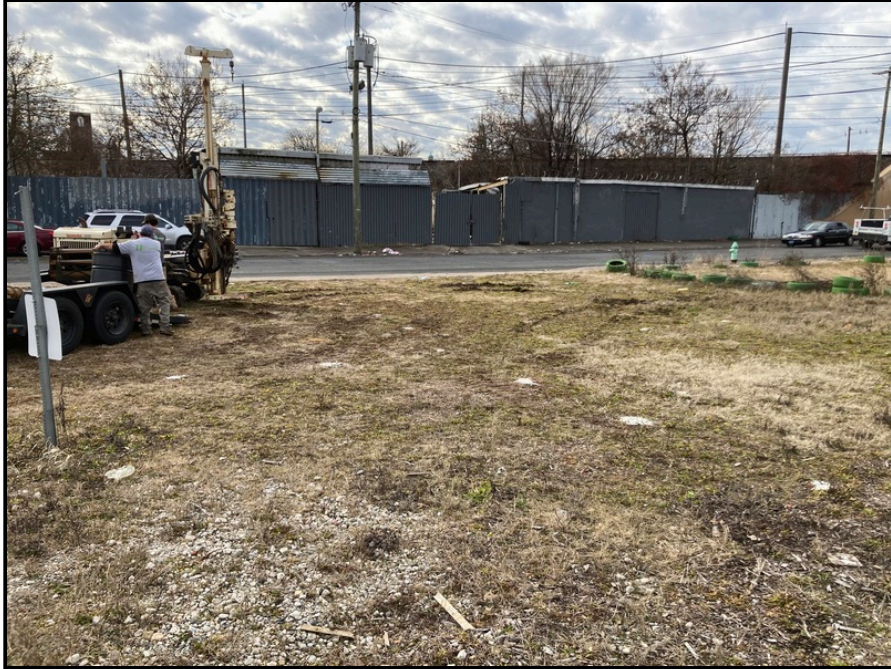
Additional AOC 2-1 delineation samples installed in the southeastern portion of the site

TTI recommended further soil investigation of the mercury exceedance detected in AOC 2-2.

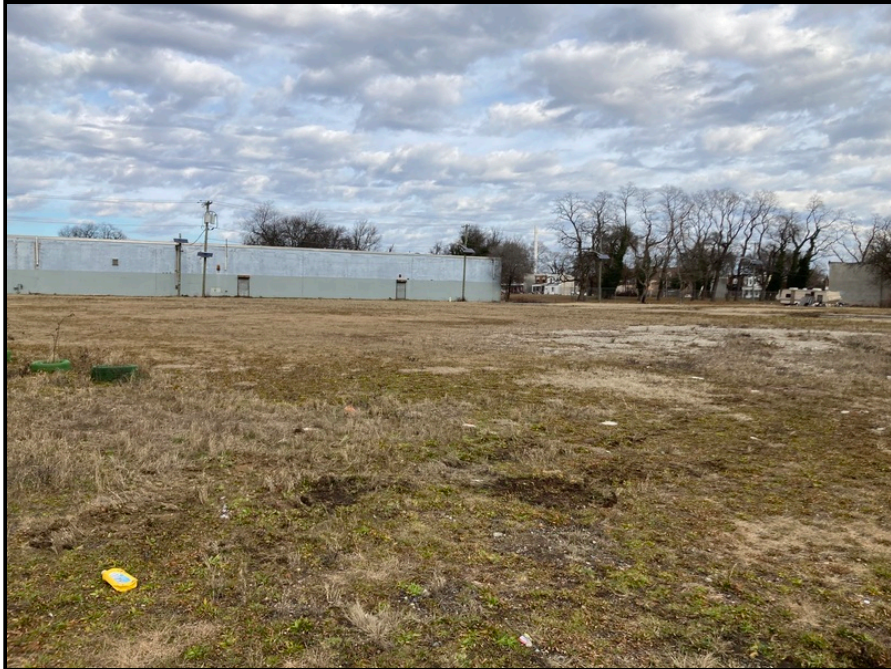
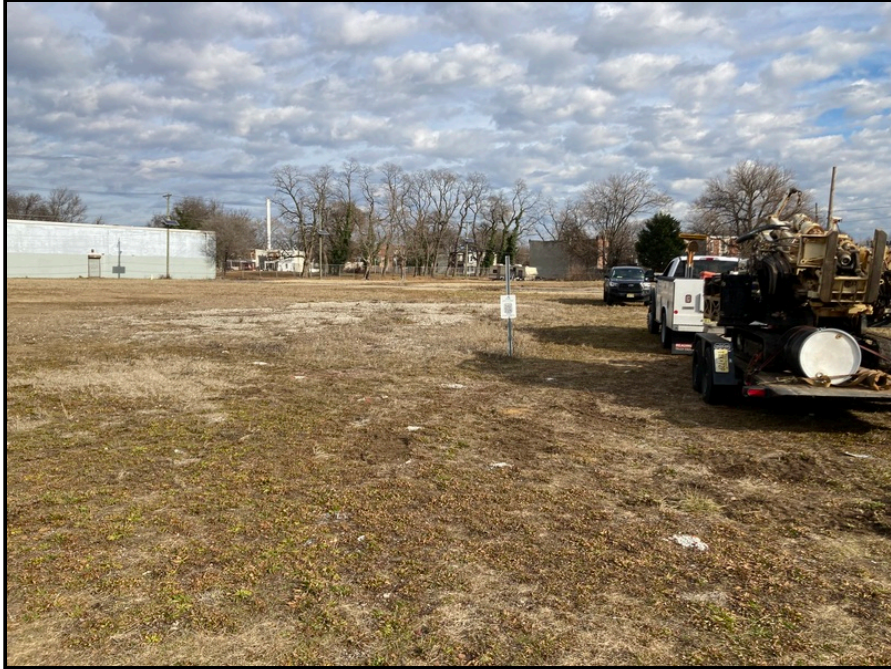
Additional AOC 9-1 delineation samples installed in the southeastern portion of the site

Benzo(a)pyrene was detected in exceedance of the NJDEP RID-SRS. in the vicinity of AOC 9. TTI conducted additional sampling in the area of AOC 9 and delineated the extent of benzo(a)pyrene contamination in soil. TTI recommends the hotspot remediation of soils impacted by benzo(a)pyrene associated with AOC 9.
