# **Analysis of Brownfields Cleanup Alternatives**

**Dominick Andujar Park  
Erie and Point Streets  
(Block 12, Lots 1, 3-9, 18-21 and Block 14, Lots 29-35 and 37)  
Camden, New Jersey**

Prepared by BRS, Inc. for the

November 2020

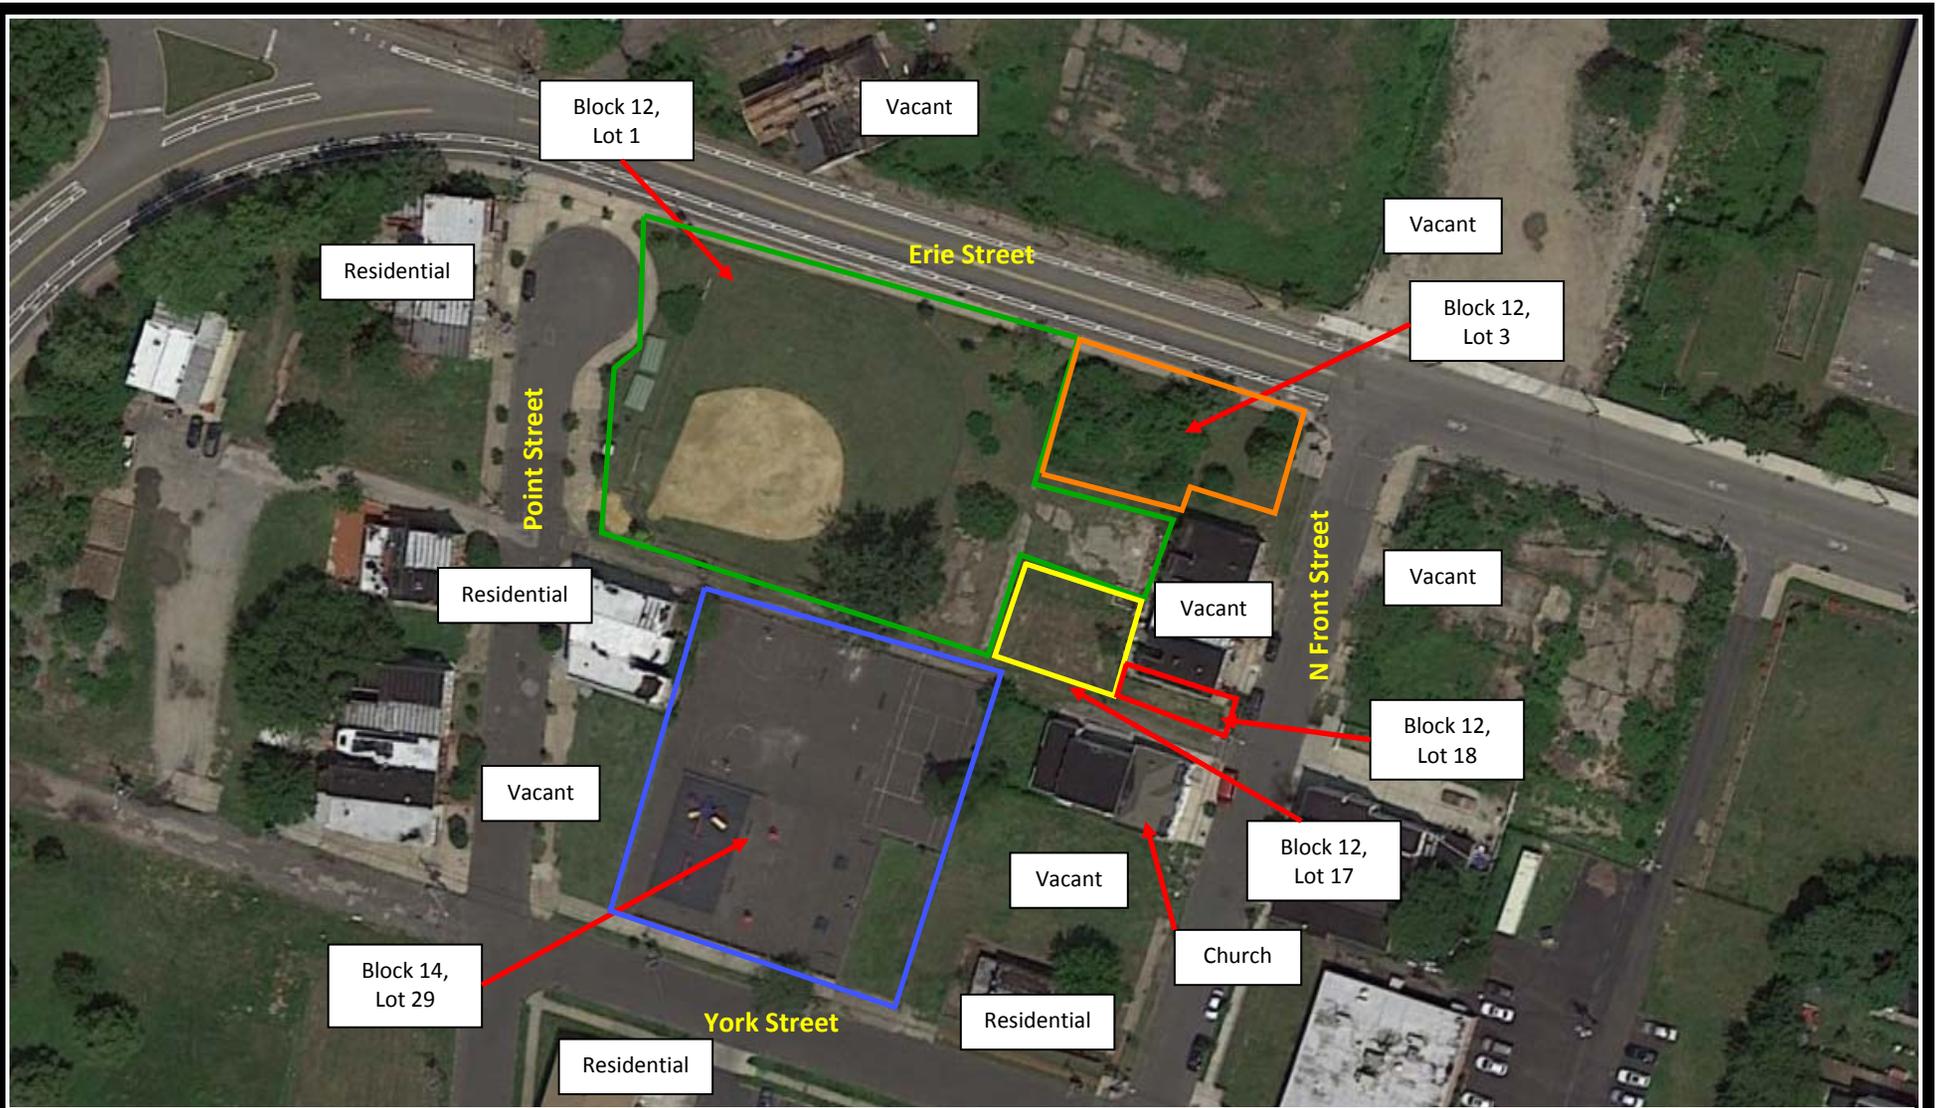
**Figure 2.0:**  
**Site Diagram**

Andujar Park  
 Erie and Point Street  
 Block 12, Lots 1, 3, 17 & 18  
 Block 14, Lot 29  
 Camden, Camden County, New Jersey 08102

- Legend**
- AOC 1: Regulated Heating Oil UST
  - AOC 2: Former Automotive Waste/Scrap
  - AOC 3: Historic Fill (site wide)
  - AOC 4: Former Boiler Room
  - AOC 5: Former Chemical Storage Building A (1926)
  - AOC 6: Former Chemical Storage Building B (1891)
  - AOC 7: Electrical Transformers and Capacitors
  - AOC 8: Historic Site Operations
  - AOC 9: Former Coal Yard
  - AOC 10: Metallic Anomaly #1
  - AOC 11: Metallic Anomaly #2
  - AOC 12: Metallic Anomaly #3
  - AOC 13: Metallic Anomaly #4
  - AOC 14: Metallic Anomaly #5
  - AOC 15: Metallic Anomaly #6
  - AOC 16: Metallic Anomaly #7
  - AOC 17: Metallic Anomaly #9
  - AOC 18: Metallic Anomaly #10

Additional remedial investigation and remedial action will be required for four (4) of these Areas of Concern (AOCs) on the Northern Portion of the park as discussed below.

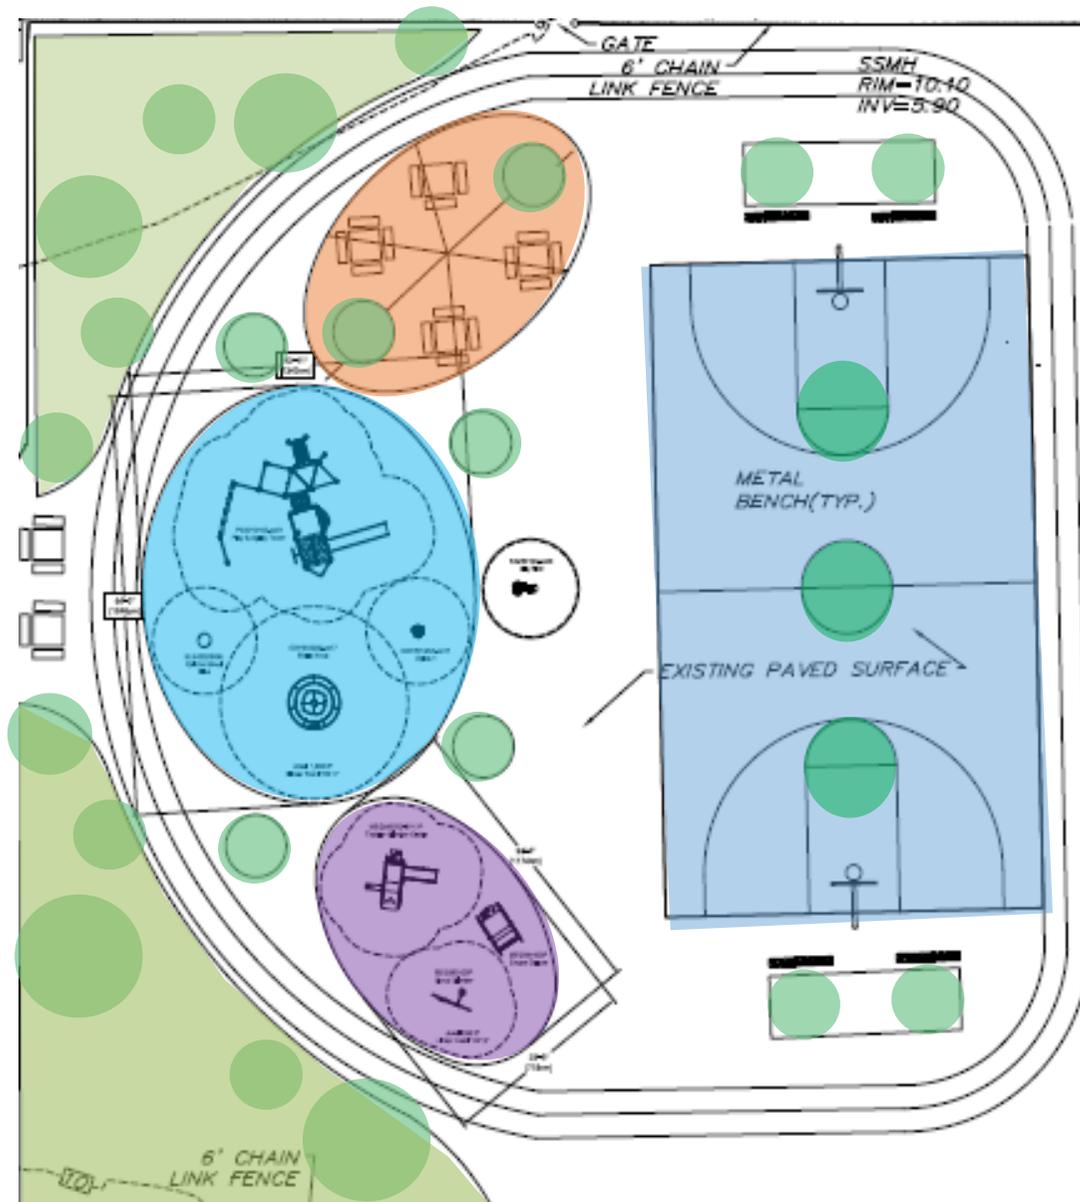
# Dominick Andujar Park – Phase I (South Side)

Based on community design vision, the South Park, Phase I, includes the following features:

- Playground for 5-12
- Playground for 2-5
- Fitness Bike
- Fitness track
- Basketball Court
- Shaded seating
- Picnic Area
- Trees

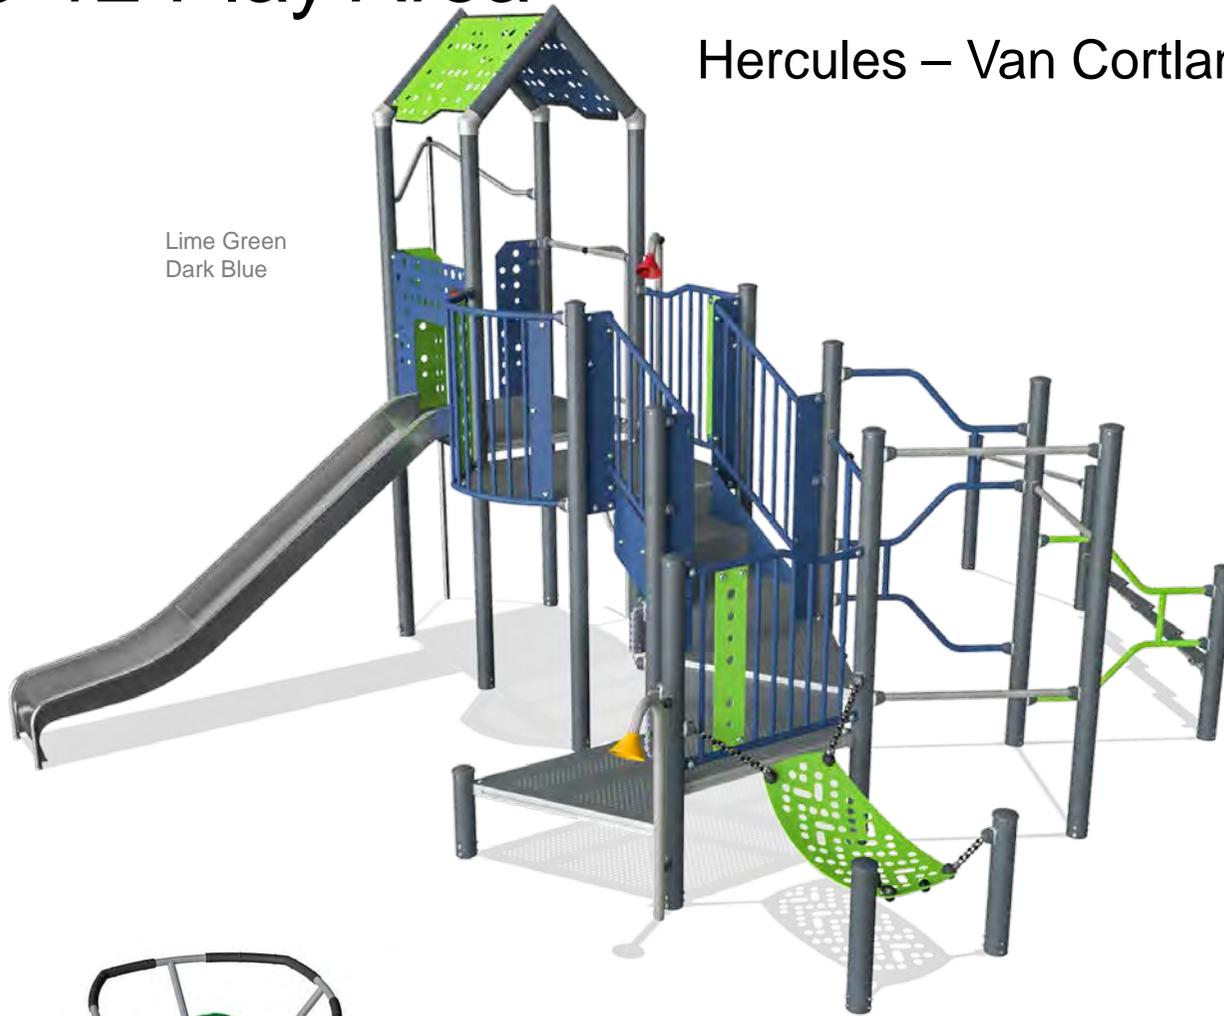
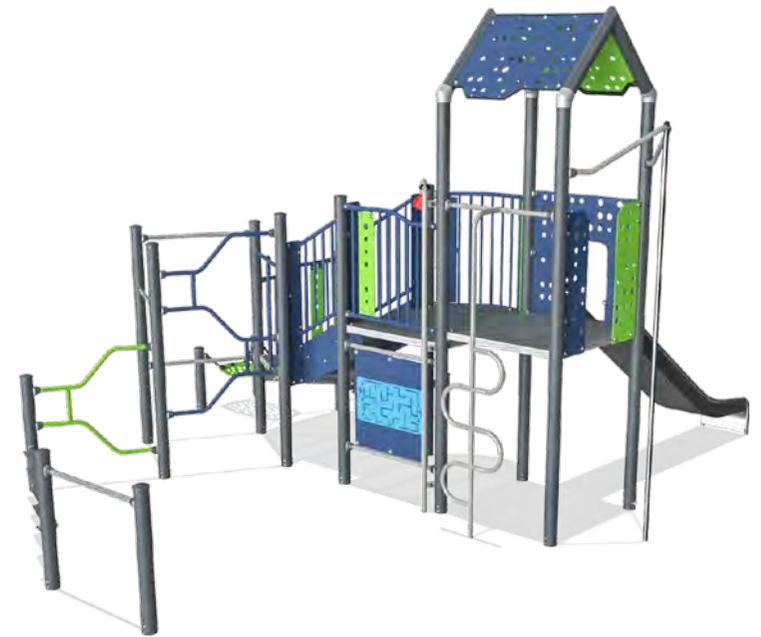
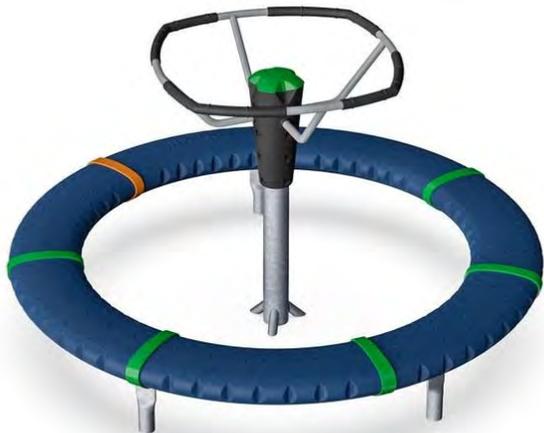
# 5-12 Play Area

Hercules – Van Cortland

Item no. PCX210100-0901	
<b>General Product Information</b>	
Dimensions LxWxH	17'11" x 21'9" x 12'7"
Age Group	5-12
Play Capacity	34 children
Color Options

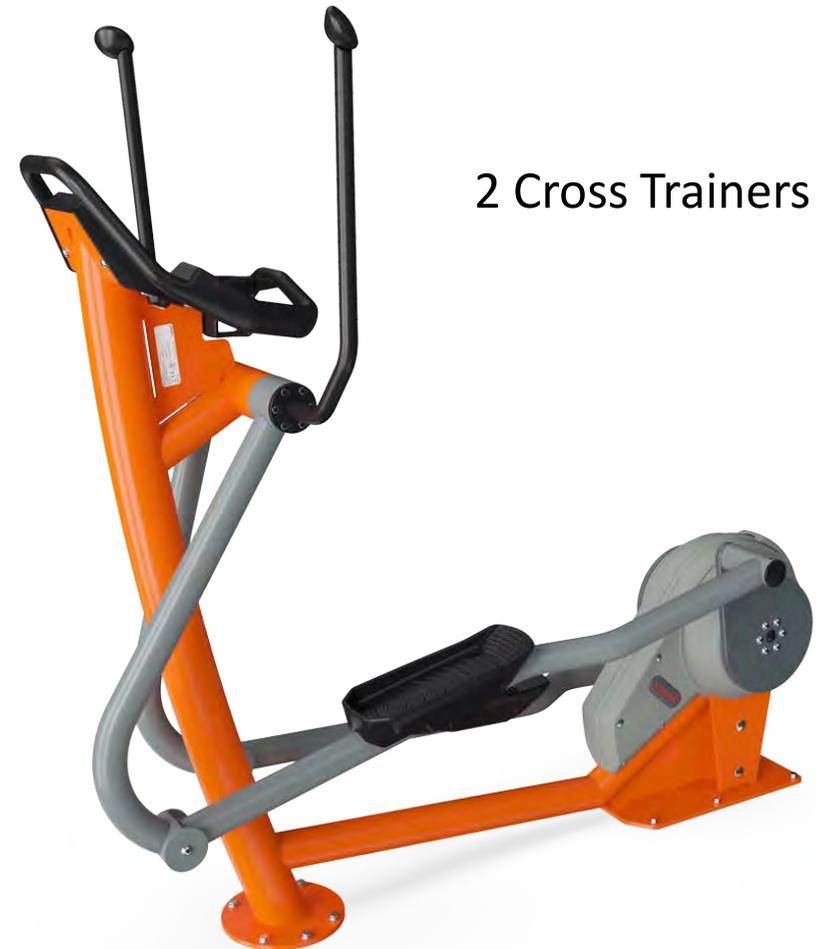
2 Cross Trainers

- Durable Construction
- Smartphone mounting
- Free Health Tracking App
- Feedback & Data for users
- Bluetooth

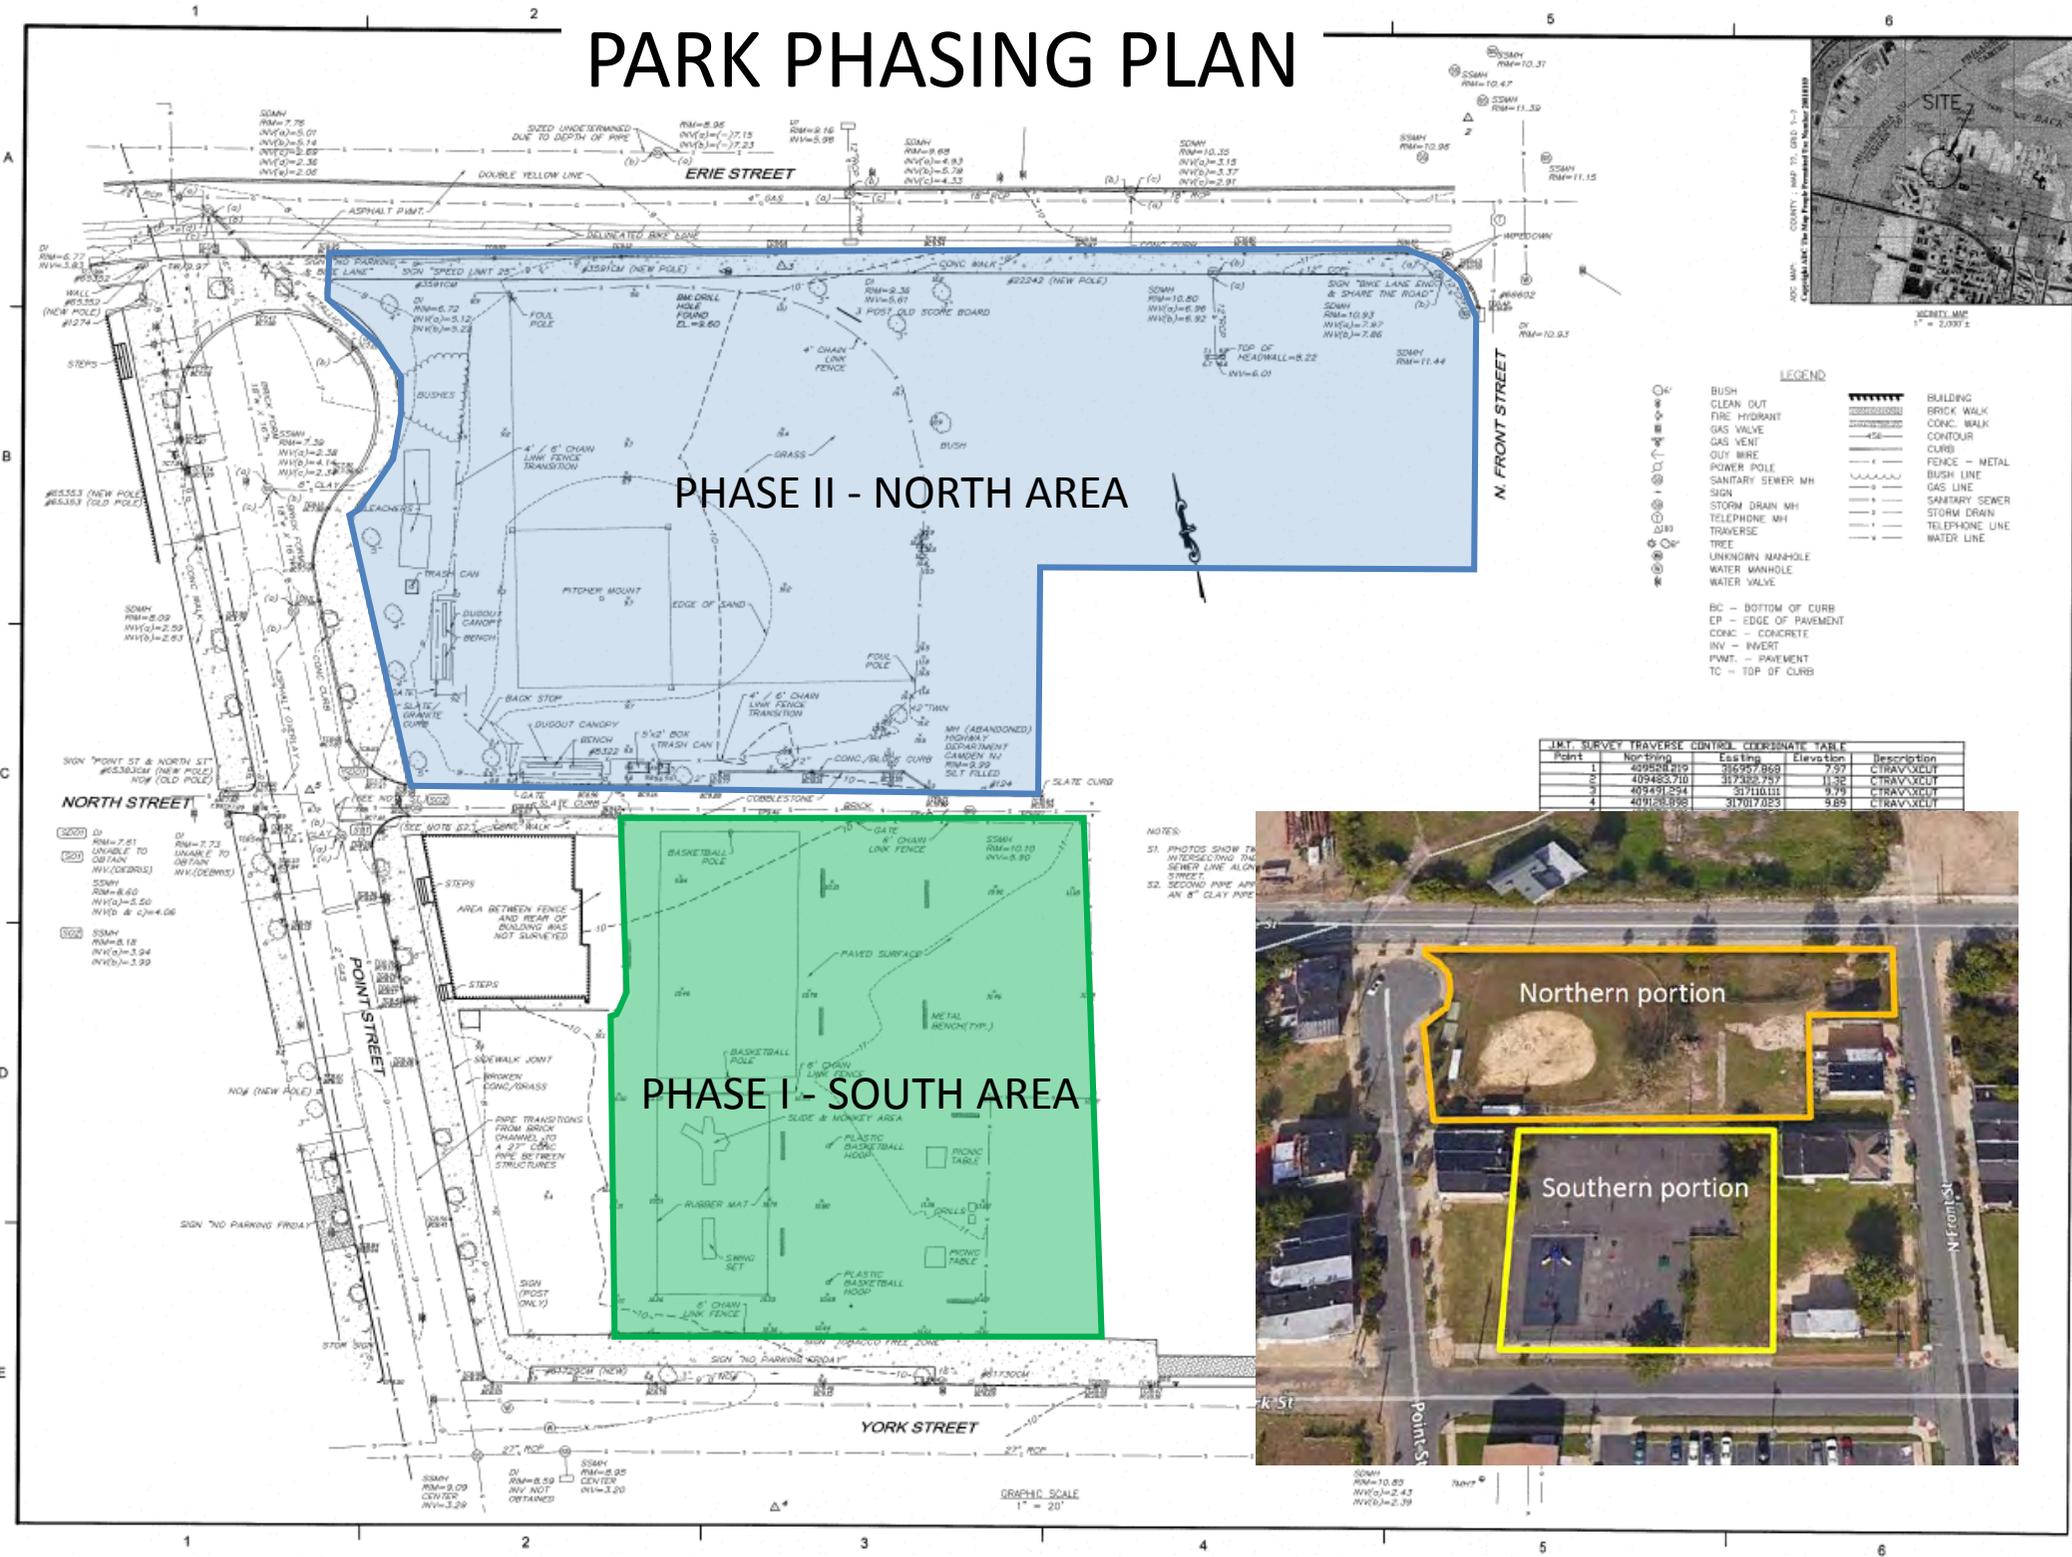
# PARK PHASING PLAN

PHASE II - NORTH AREA

PHASE I - SOUTH AREA

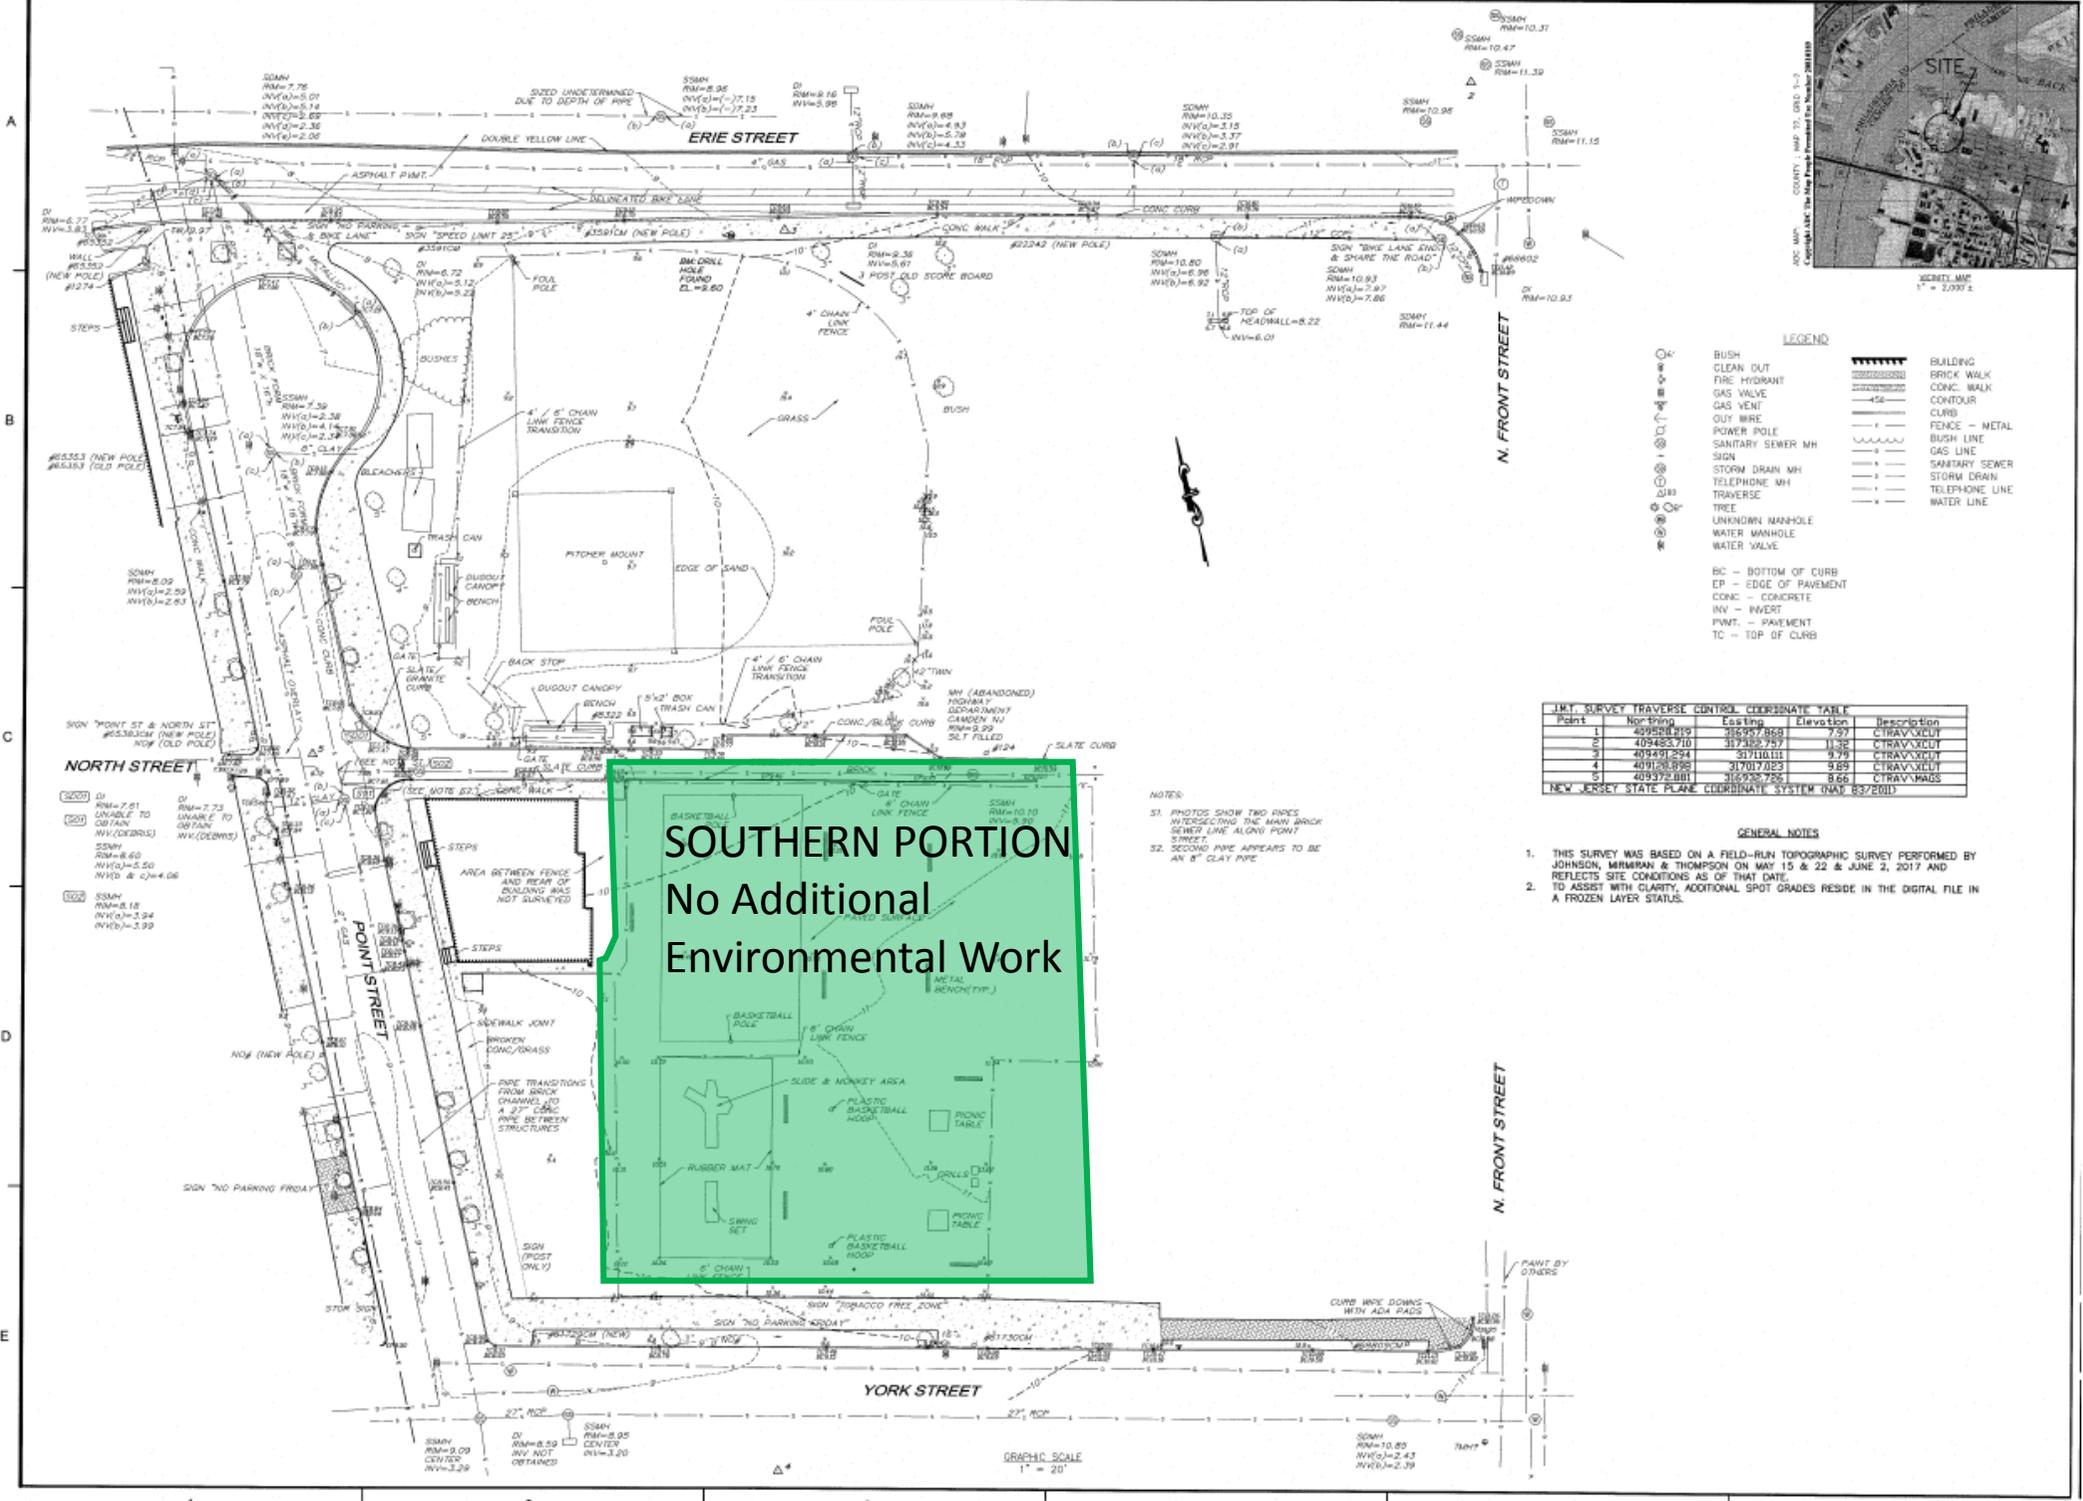
**SOUTHERN PORTION**  
**No Additional**  
**Environmental Work**

No further action (site closure) with unrestricted use has been recommended for the Southern Portion of the park. EPA subgrant funds will be used to develop the Response Action Outcome document for the southern portion of the site.

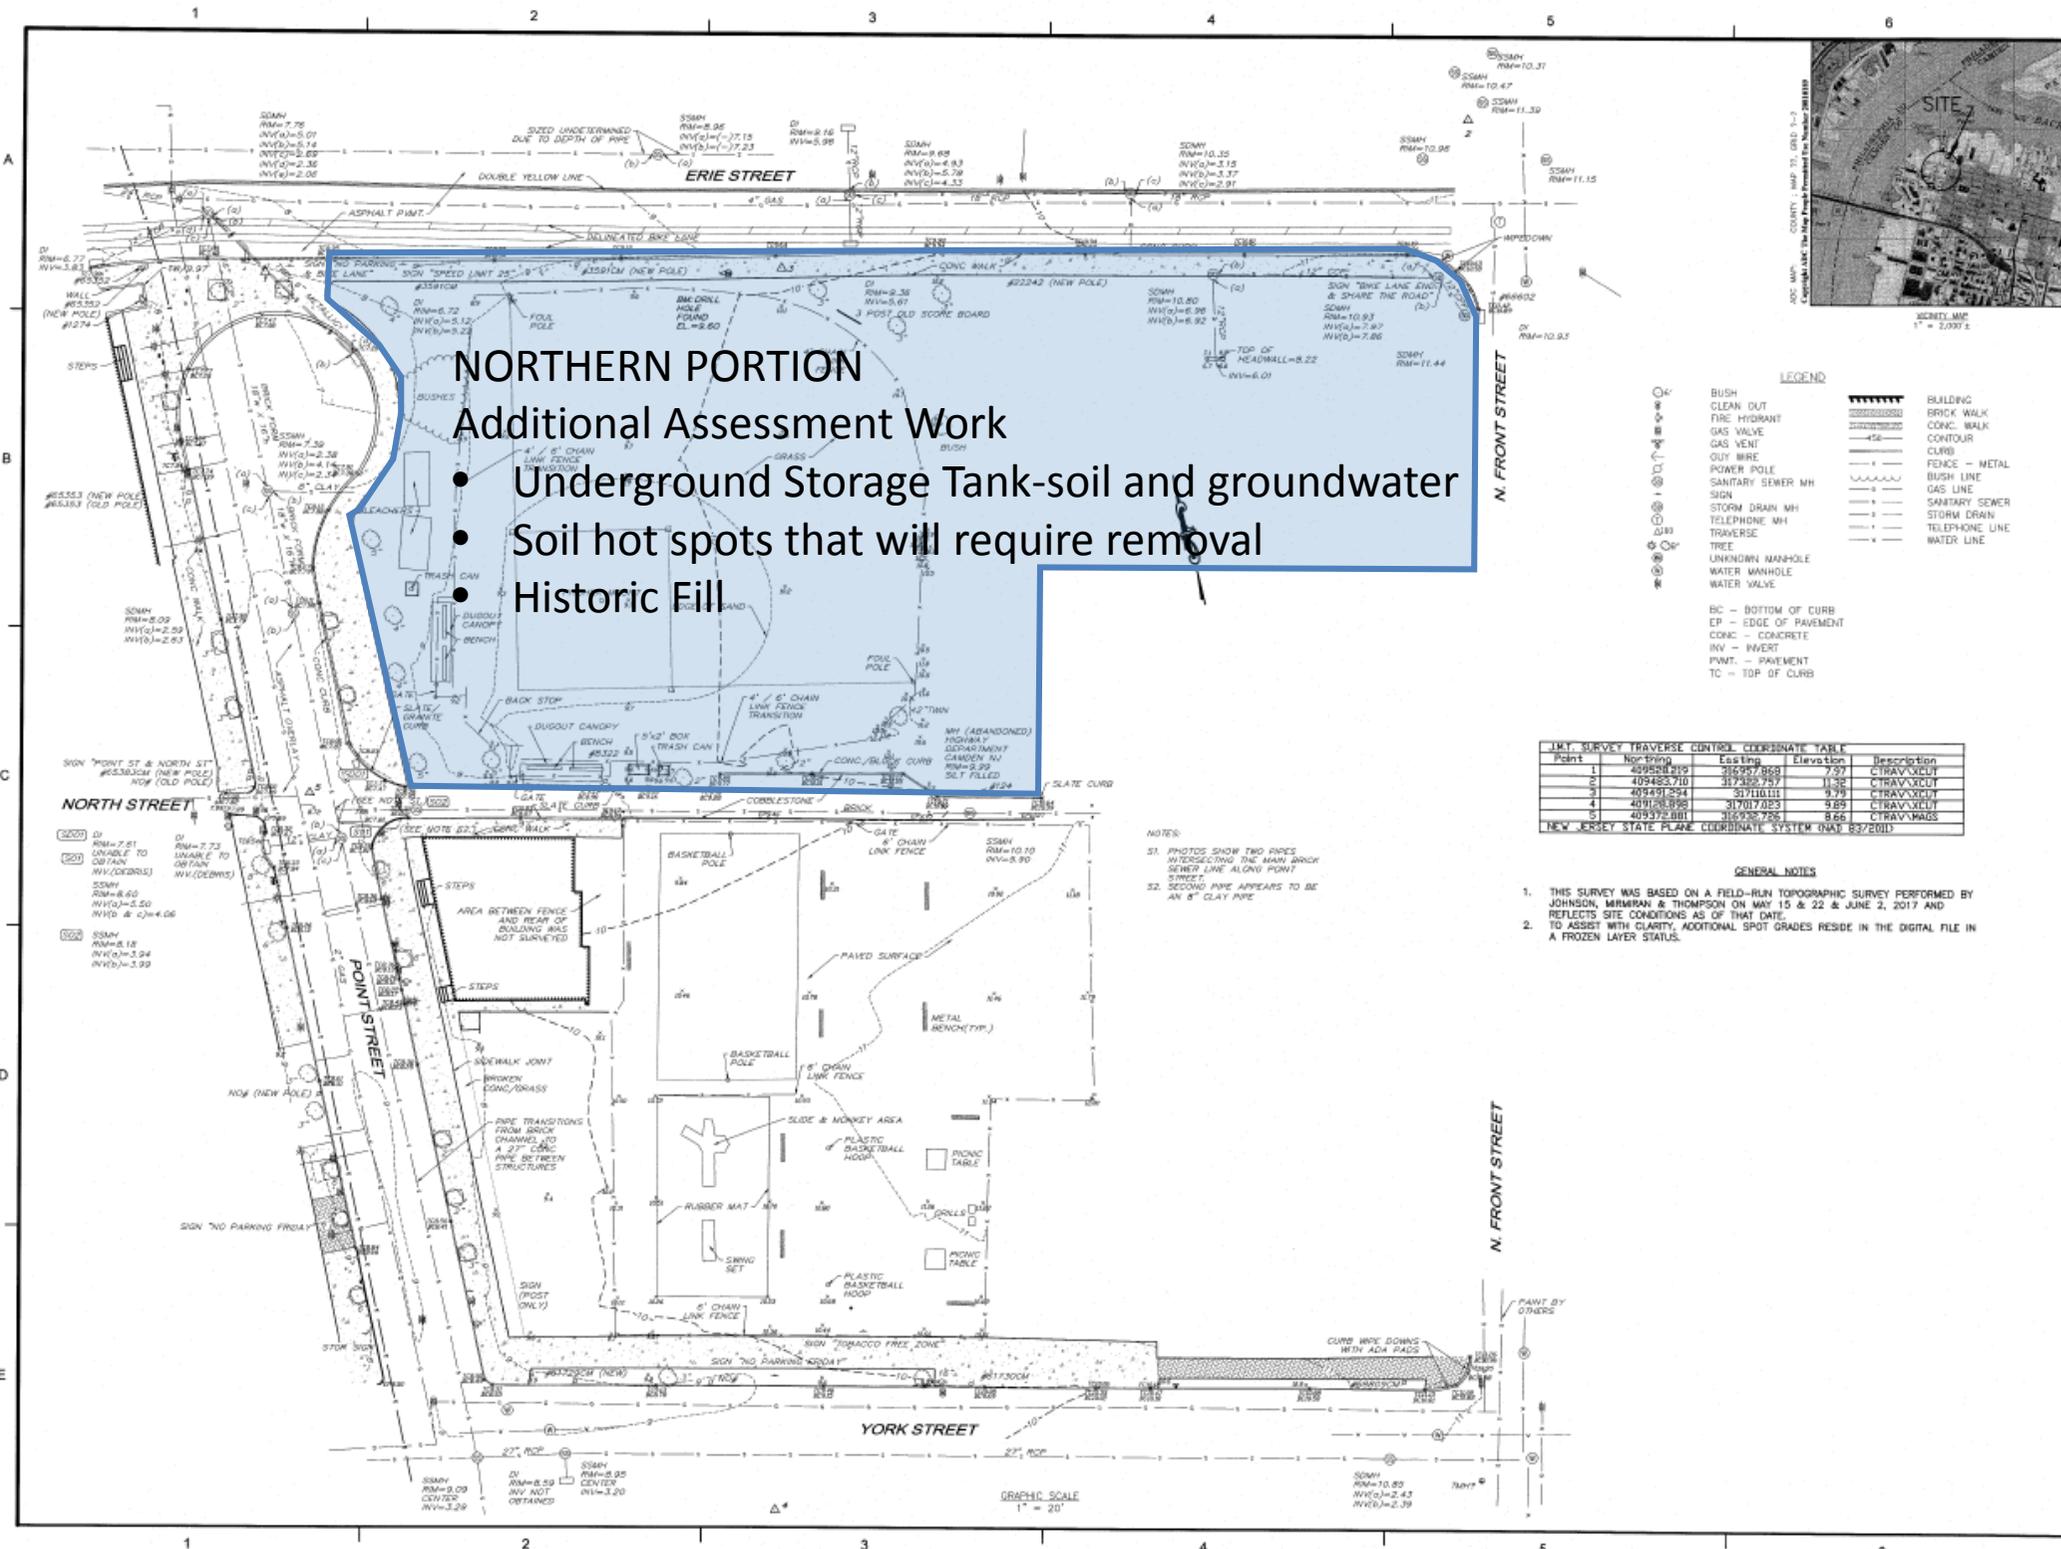
**NORTHERN PORTION**  
**Additional Assessment Work**

- Underground Storage Tank-soil and groundwater
- Soil hot spots that will require removal
- Historic Fill

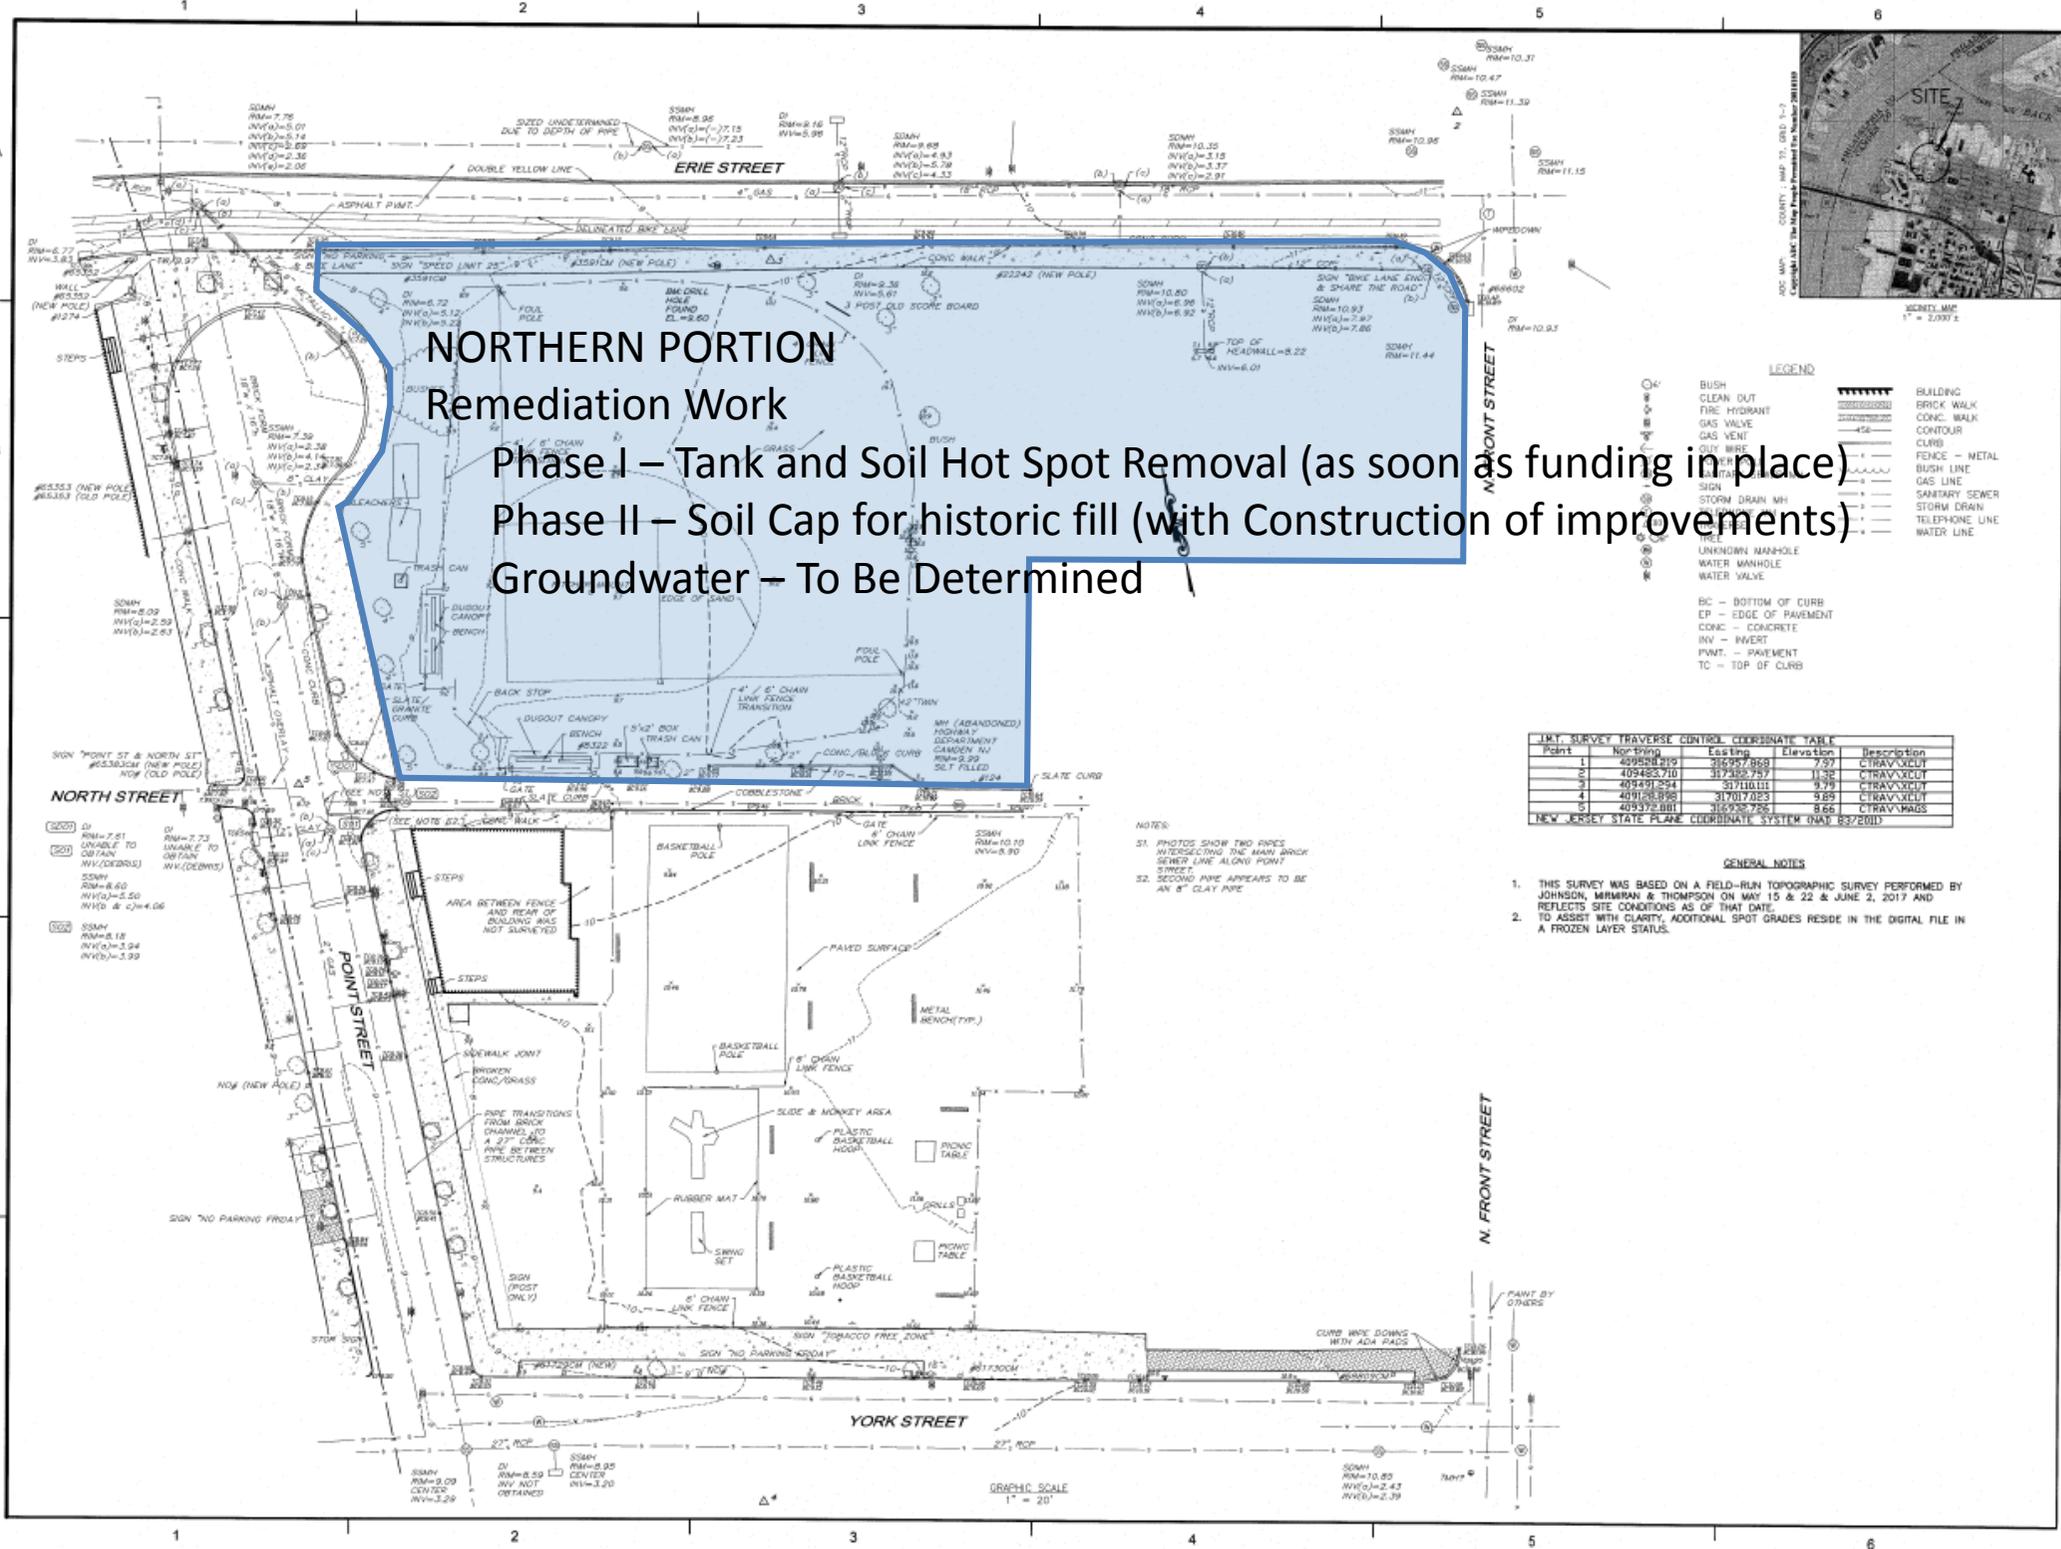
**NORTHERN PORTION**  
 Remediation Work  
 Phase I – Tank and Soil Hot Spot Removal (as soon as funding in place)  
 Phase II – Soil Cap for historic fill (with Construction of improvements)  
 Groundwater – To Be Determined

Remediation is going to be taking place in two phases. EPA grant funds will be used for the Phase I, which is anticipated to consist of hot spot soil removal and UST removal.

Phase II of remediation will involve emplacement of the cap to address historic fill in the Northern Portion of the site. This is being done in conjunction with the ballfield improvements at a later date. Camden County will be performing the capping work and use of EPA funding for this effort is not currently planned. This second, future phase of remediation will include an Engineering Control, recording of a deed notice. A virtual groundwater classification exemption area (CEA) as Institutional Controls may be conducted under either phase of remediation (to be determined).
