Closure and Environmental Remediation of the Former Harrison Avenue Landfill

Prepared For The Camden Redevelopment Agency

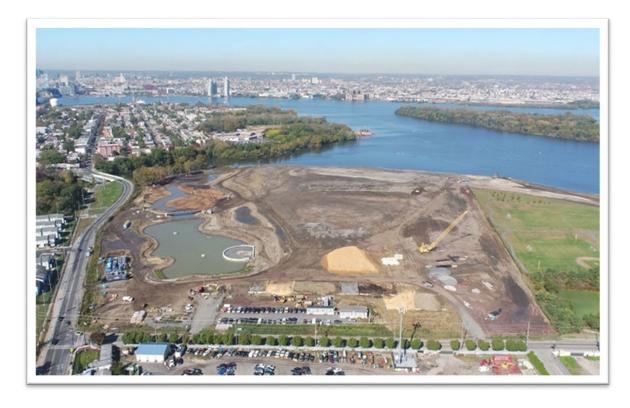
Operational Area of the Cramer Hill Waterfront Park (October 2019)

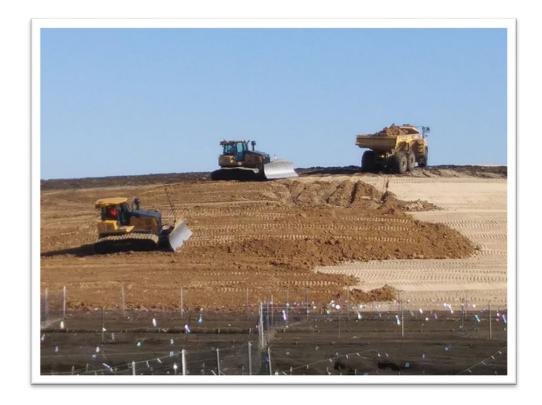
Capping operations underway near the Summit Vista (October 2019)

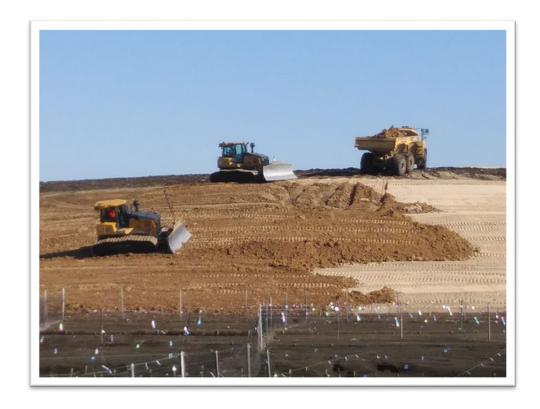
Capping operations underway near the Summit Vista (October 2019)

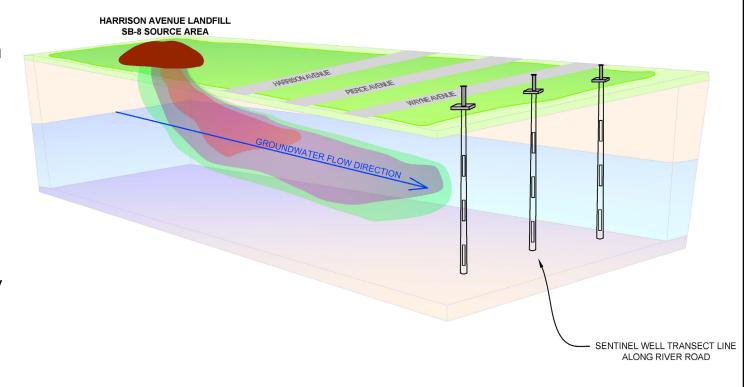
General Model of a Groundwater Plume

- Contamination seeps downward to the water table, dissolves into the water and begins to move with groundwater flow.
- Chlorinated VOCs (cVOCs) are denser than water so they 'sink' and continue to dissolve as they sink.

- Dissolved cVOCs in groundwater form the 'plume'.
- Metals are adsorbed and absorbed to soil.
- cVOCs do not sorb to soil and do not easily break down and typically will occur in elongated plumes.
- Away from the source clean water infiltration from above can create a clean water lense above a plume.

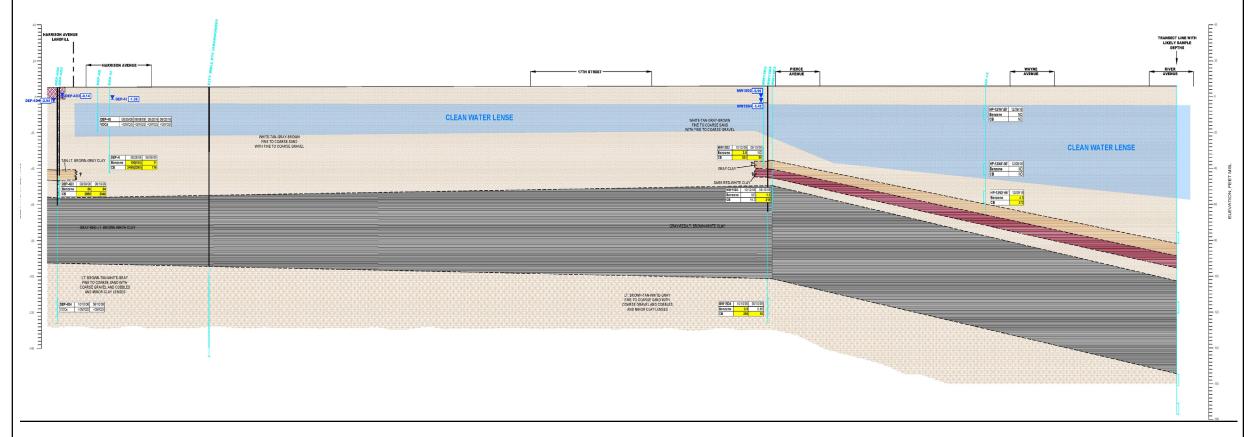
Geological Cross-Section – Harrison Avenue to River Avenue

• Data demonstrates clean water lense, shown above in blue, at the top of the water column once southeast of Harrison Avenue.
